## PLASTERBOARD RECTIFICATION RESULTING FROM FLOOD INUNDATION

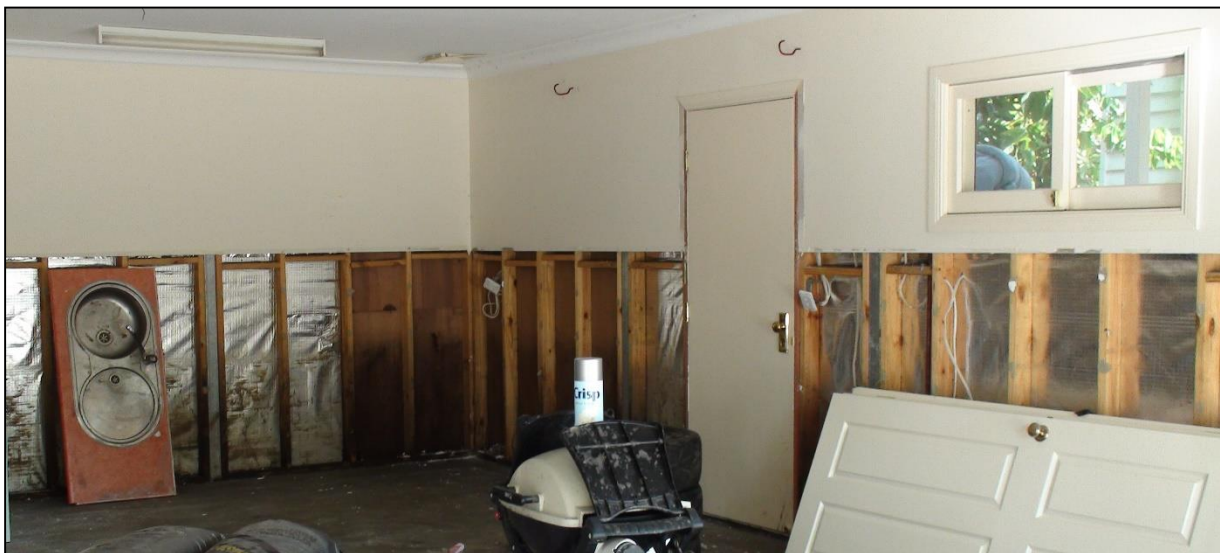
### Method 1

Remove the damaged sheets to approximately 300mm above the high water mark preferably at the nearest joint above the water line. Given sheets are either 1200 mm or 1350 mm high it will either be at these joints or at full wall height (see 2 below).

Because the replacement joint will most likely be made up of one new recessed edge board abutting the existing sheet (a butt edge), the joint should be treated as a butt joint. There will be a crown created which may cause glancing light issues and setting out over 600mm (the same
